# Manhole Inspection Summary

Manhole # S33GG\_022MH

Insp Date: **2/15/07 12:12 PM**

**Location** Address: **11 MT ROYAL AVE**

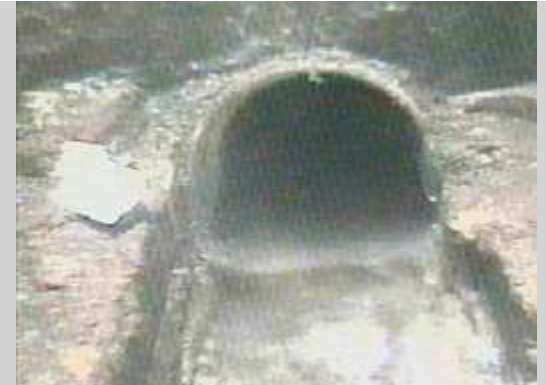
### 24 in. Circular Gravity Sewer Pipe Out @ 12 O'Clock

Pipe Material: **Unknown** ☒ Pipe Lined

Invert Depth: **15.57** (ft.) Flow Characteristics: **Fast**

Infiltration: **None** Pipe Seal Cond: **Unknown**

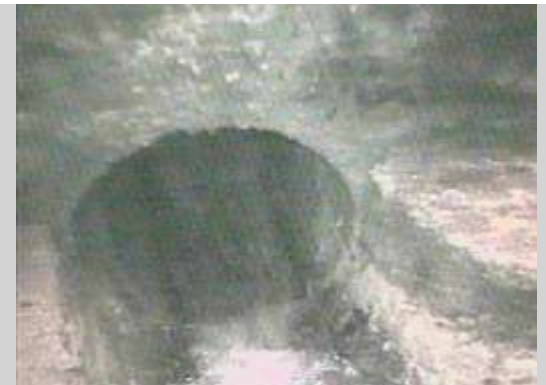
### 16 in. Circular Gravity Sewer Pipe In @ 6 O'Clock

Pipe Material: **DIP/CI** ☐ Pipe Lined

Invert Depth: **15.50** (ft.) Flow Characteristics: **Fast**

Infiltration: **None** Pipe Seal Cond: **Unknown**

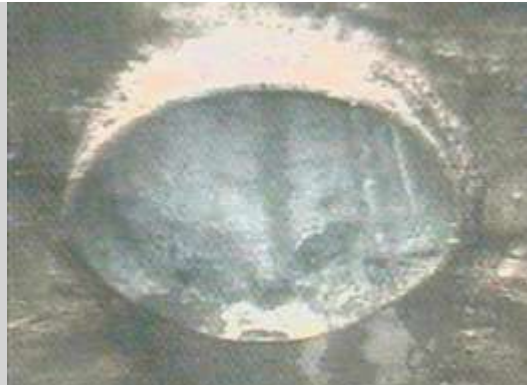
14 in. Circular Gravity Sewer

Pipe Material: **Unknown**

Infiltration: **None**

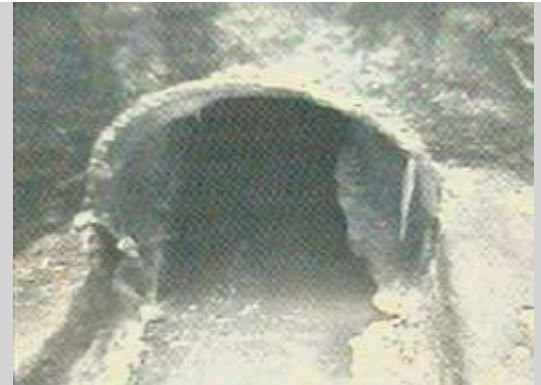
Drop In @ 9 O'Clock

Drop Condition: **Open**
